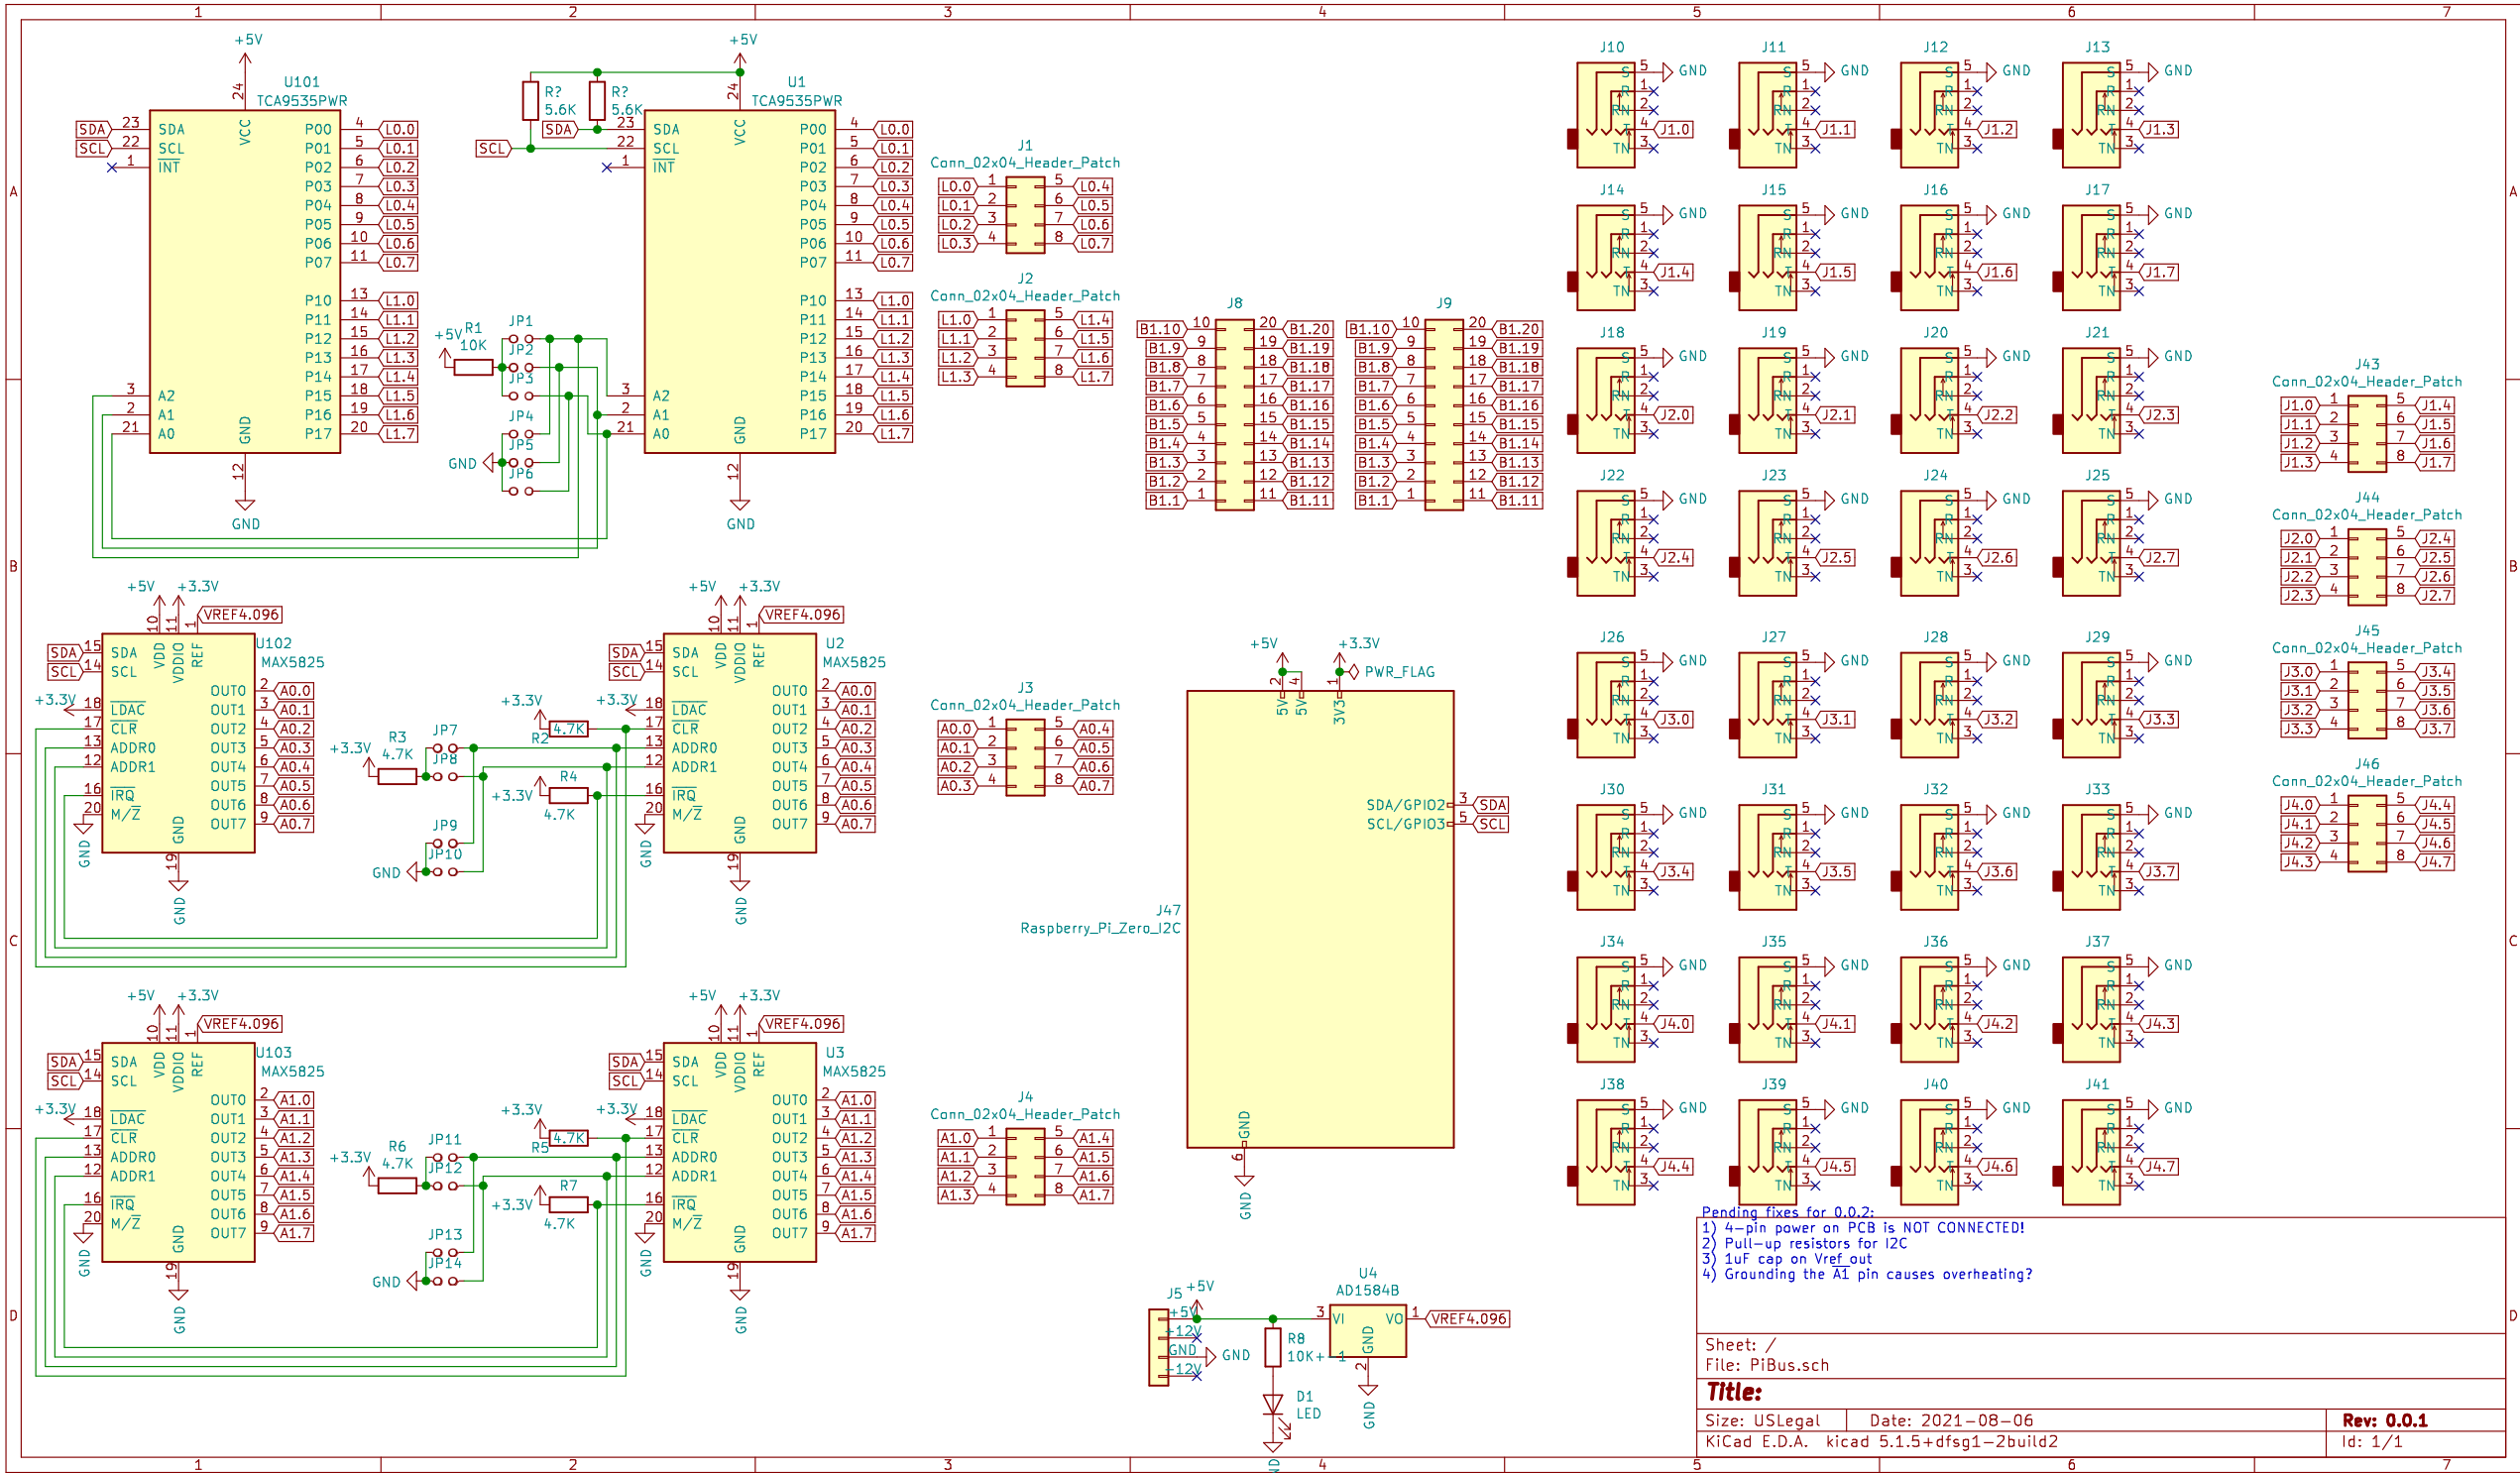
Pending fixes for 0.0.2:
 1) 4-pin power on PCB is NOT CONNECTED!
 2) Pull-up resistors for I2C
 3) 1uF cap on Vref_out
 4) Grounding the AI pin causes overheating?
